BIRTLE TRANSMISSION PROJECT Construction Environmental Protection Mapbook

Version: Final 1.0

Date: June 08, 2020

Document Owner: Licensing and Environmental Assessment Department Transmission Planning and Design Division Transmission Business Unit Manitoba Hydro

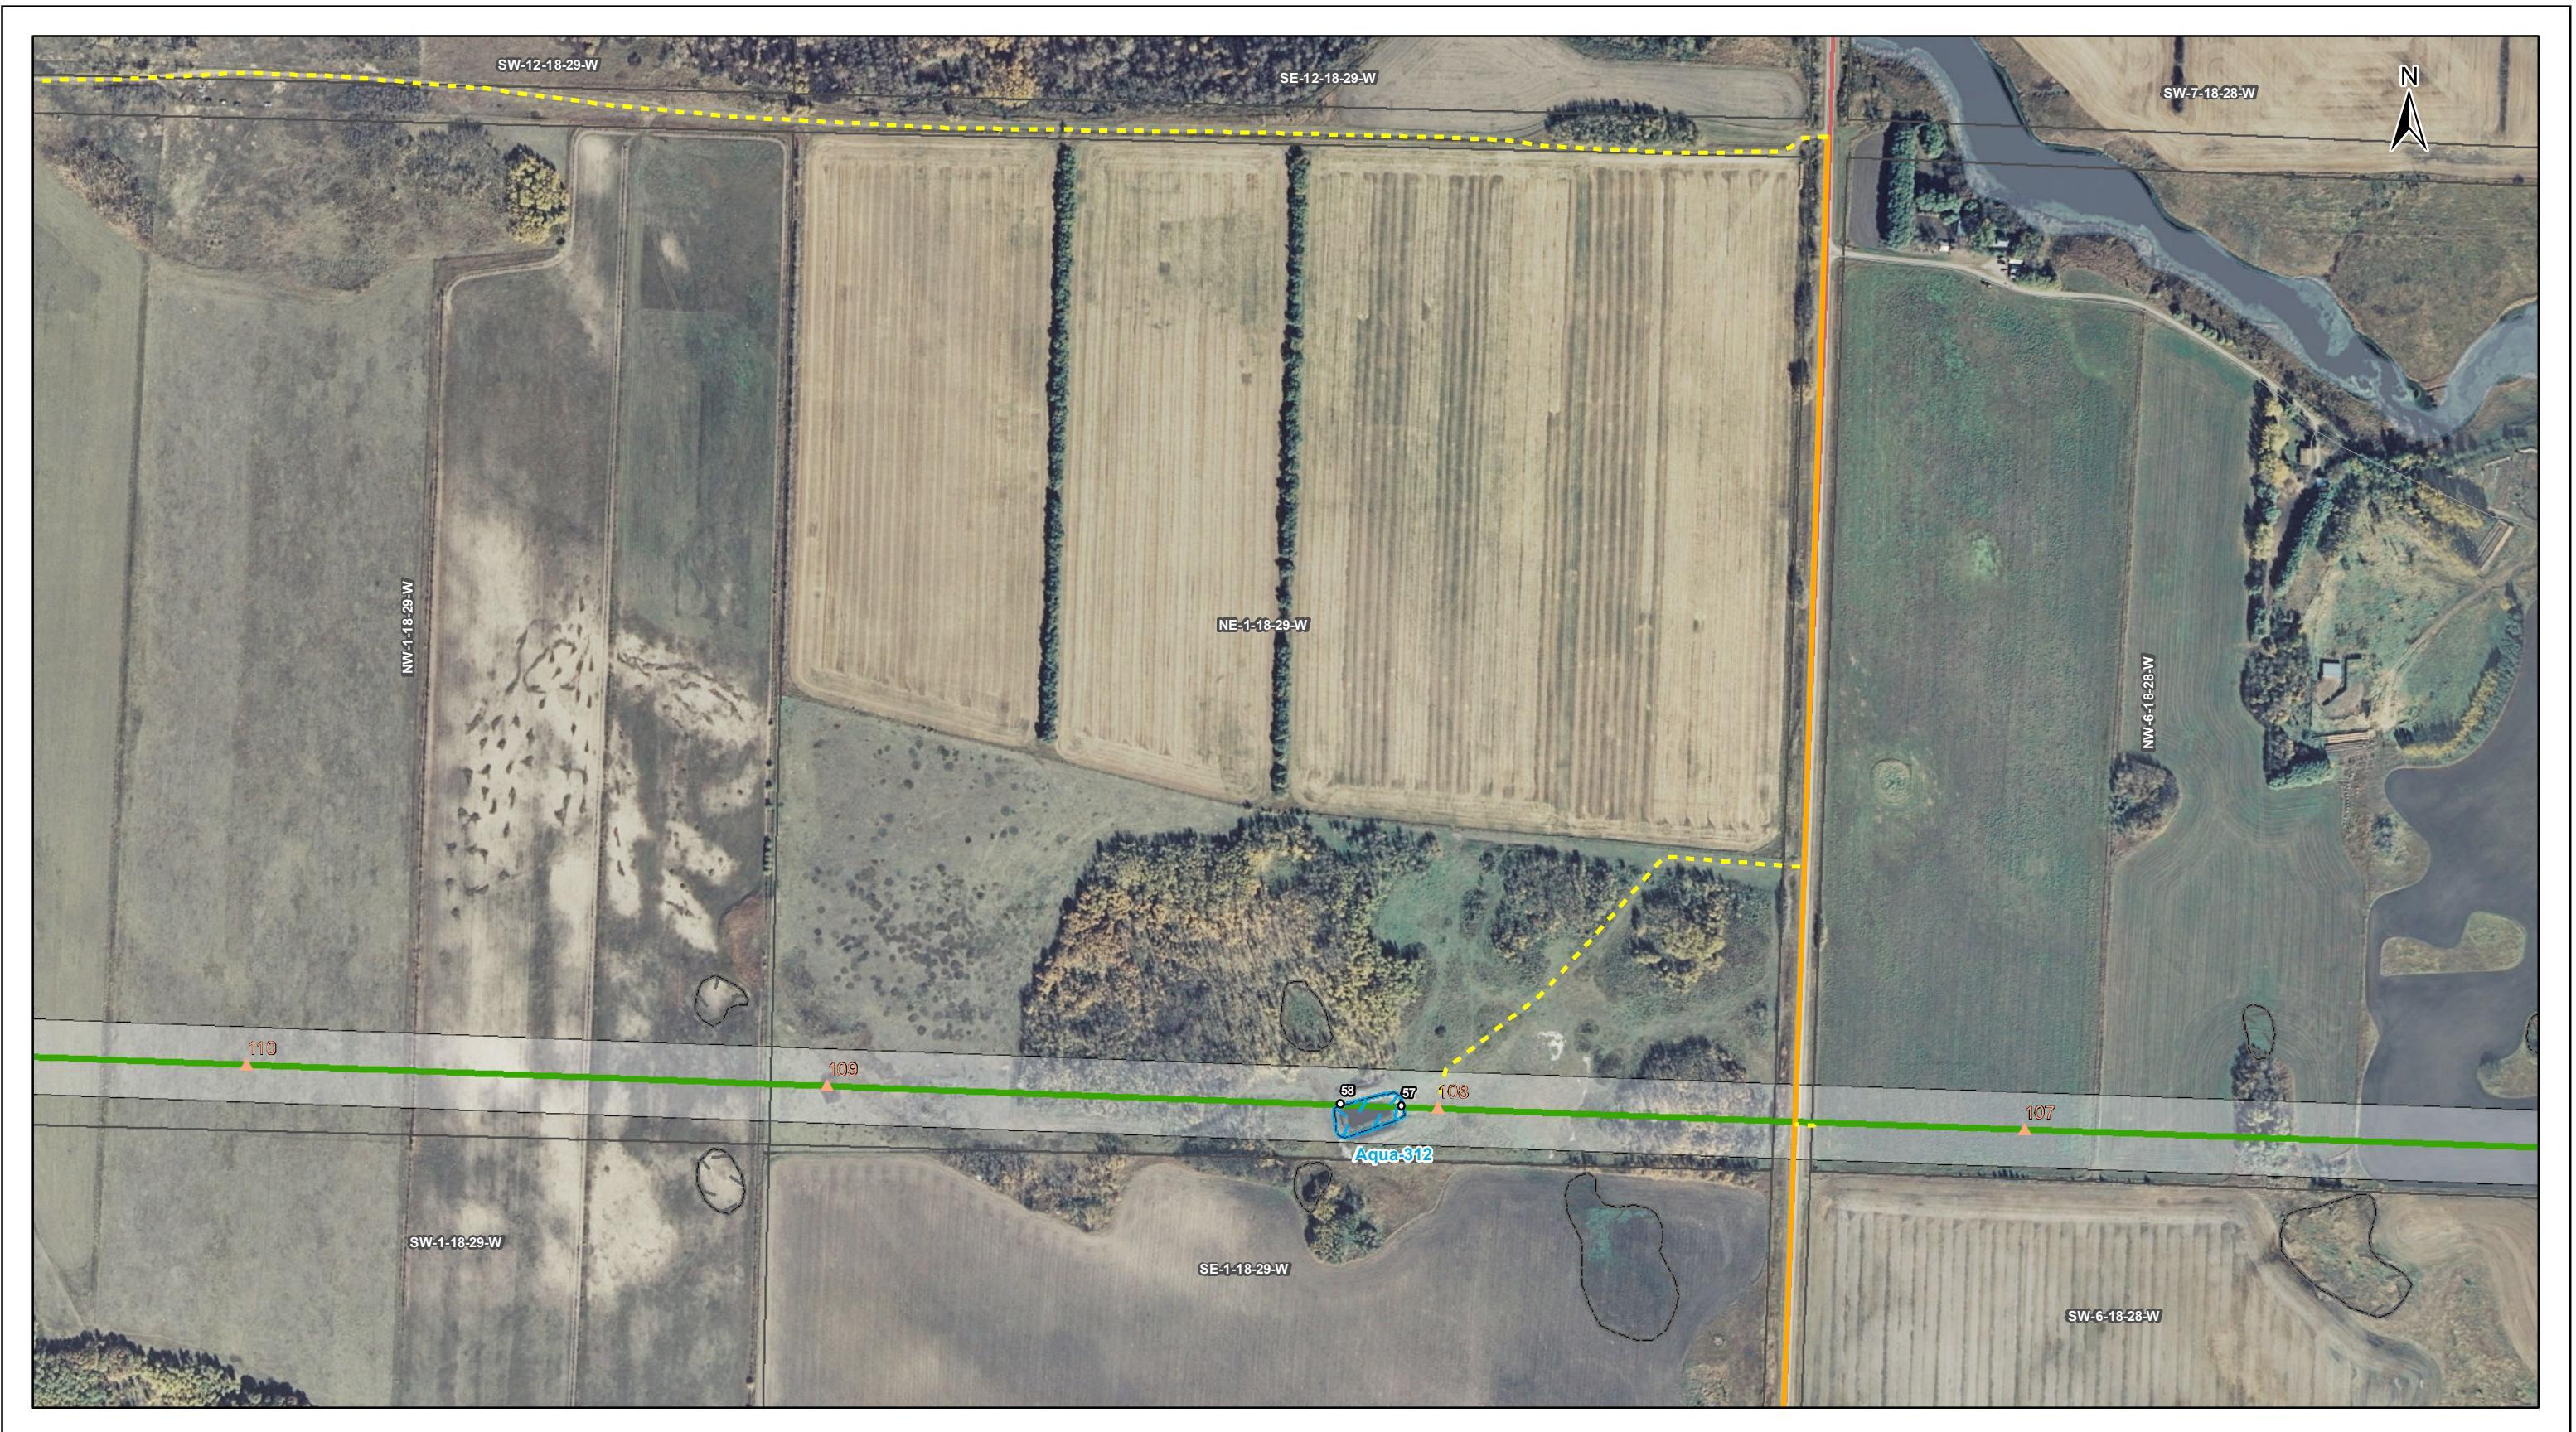
ESS Group: Wetland

- Carry out construction activities on frozen or dry ground to minimize surface damage, rutting and erosion. Construction matting will be used to protect the area from rutting and exposure to mineral soil during nonfrozen ground conditions Identify and flag a 30 m vegetated (shrub and herbaceous) buffer around site Remove trees by low ground disturbance methods within buffer The application of herbicides is prohibited Maintain shrub and herbaceous vegetation to the extent possible
- ٠
- ٠
- ٠
- ٠
