MANITOBA-MINNESOTA TRANSMISSION PROJECT

ENVIRONMENTAL MONITORING PLAN

GOLDEN-WINGED WARBLER MONITORING REPORT 2017-2020

October 2020

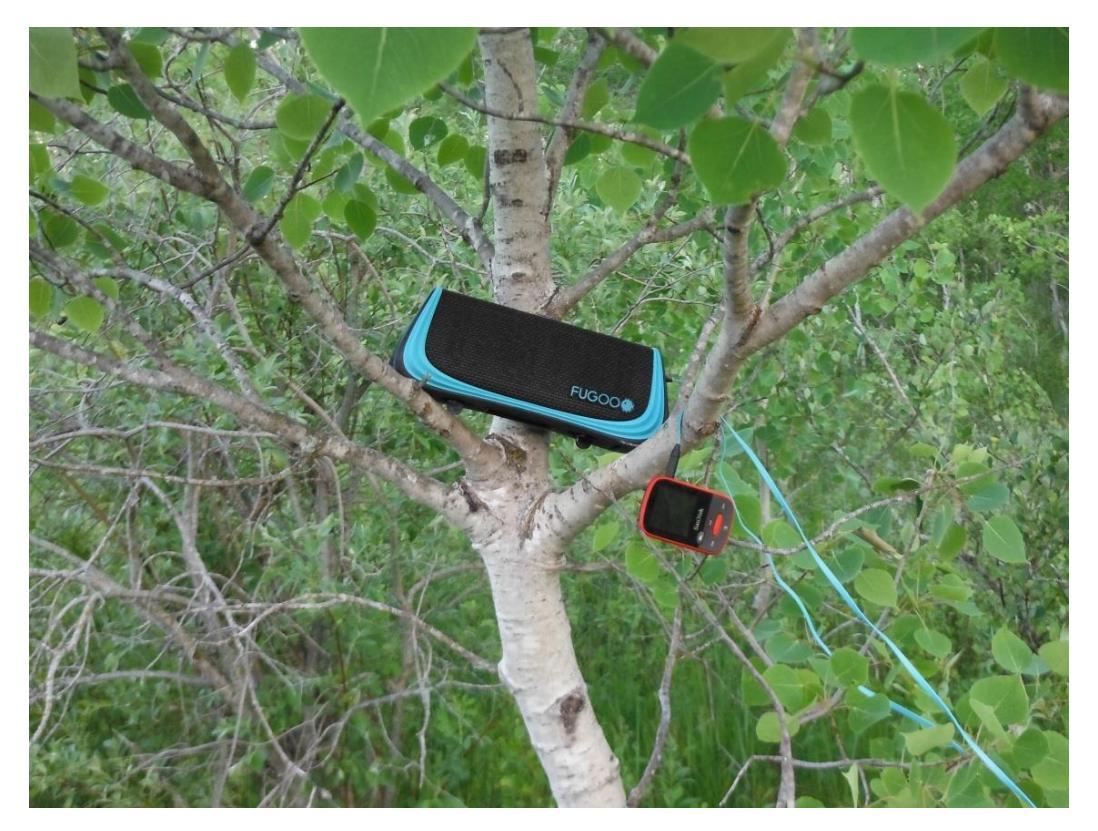
Photo 2: MP3 player (right) and speaker (left)

Surveys were conducted between 5:00 a.m. and 9:30 a.m. At each site surveyors listened for three minutes, played a recording of golden-winged warbler song for five minutes, and then listened for another two minutes. Recordings were played at 100 decibels with an MP3 player and speaker (Photo 2) (Artuso 2009). Broadcasting golden-winged warbler songs were conducted under Species at Risk Permit conditions issued by Manitoba Sustainable Development. All visual and aural detections of golden-winged warbler were noted over the 10-minute period. Incidental observations of other rare bird species were also noted during surveys.

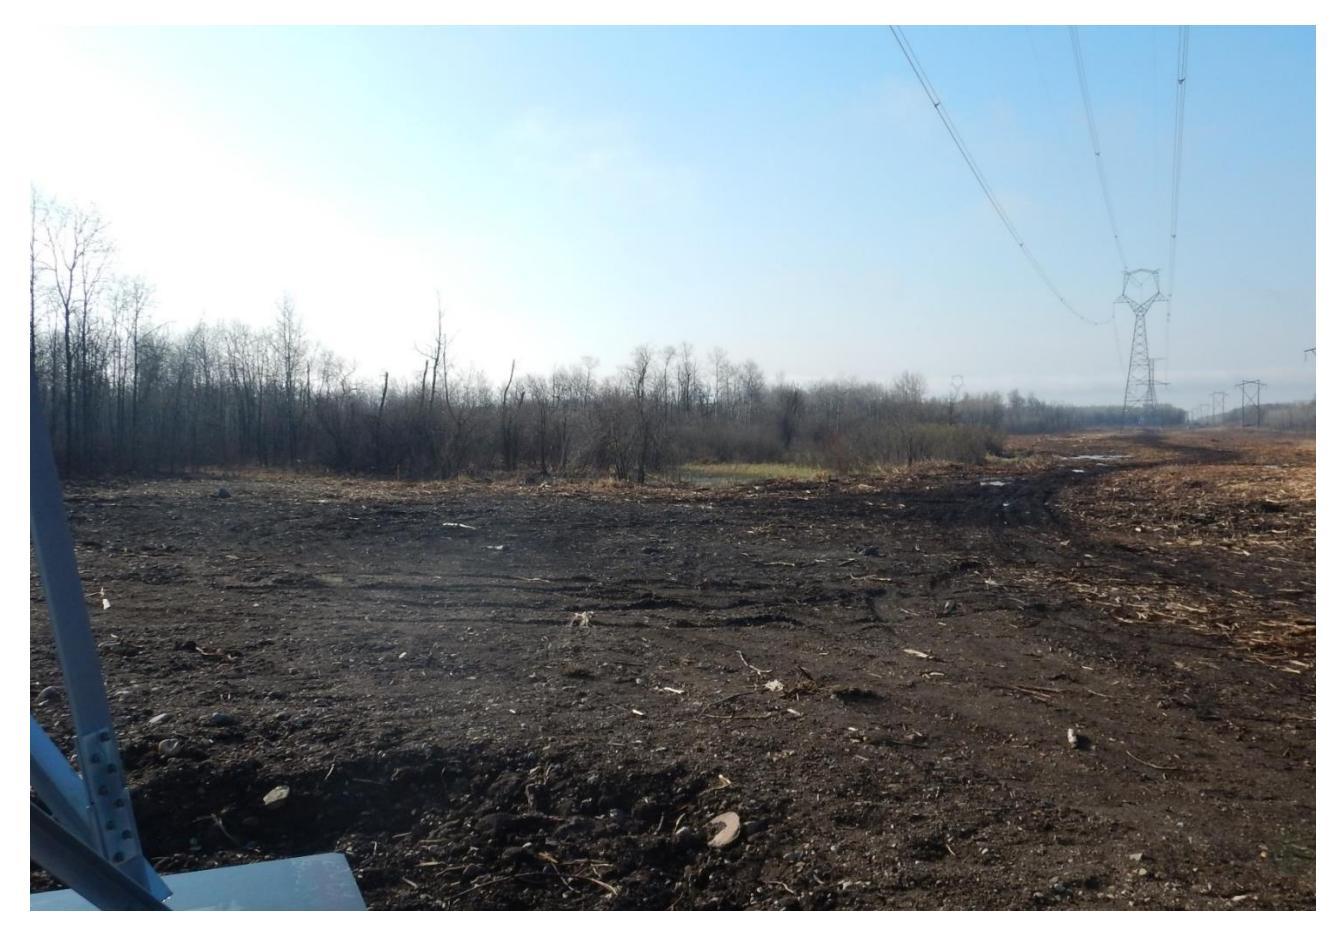
Photo 3: Feathered edge and perch trees left along the right-of-way, May 2020

As prescribed in the Golden-winged Warbler Vegetation Management Plan, a feathered edge containing a mixture of shrubs and perch trees was to remain to the extent possible in the ROW and mitigate for changes in habitat availability (WRCS 2017a). Although many sites retained perch trees along the periphery of the ROW edge, few locations had perch trees distributed in the middle of ROW. In addition, shrub growth did not appear to be retained as expected and typically remained only around small wetlands (Szwaluk 2020; Photo 5-Photo 5). Based on subjective evaluation of shrub and forb density on the ROW, the vegetation often appeared to be too sparse to be used as nesting habitat by golden-winged warblers in June 2020. The detection of most birds in the vegetation at the edge of the ROW corroborated where most of the suitable habitat remained. As a result, although habitat mitigation did not appear to meet all the objectives of immediately enhancing or maintaining golden-winged warbler habitat throughout the ROW, it did not affect population abundance. It is expected that by next growing season (2021), tall shrub cover (>4 m) will be increase in numerous areas along the ROW (Szwaluk 2020), increasing habitat suitability over the entire ROW for breeding golden-winged warblers.

No additional mitigation actions appear to be required at this time. It is anticipated that as vegetation regrows on the ROW it will become more suitable for golden-winged warblers and should attract more individuals. If unanticipated effects are evident that would reduce the quality of golden-winged warbler habitat (e.g., substantially limited shrub and forb growth on the ROW), additional mitigation measures such as shrub planting would be prescribed at that time. As recommended in the Manitoba-Minnesota Transmission Project Environmental Monitoring Plan, further monitoring will occur in 2021 to examine for this possible outcome. Further analyses will also be required to assess the magnitude of predicted effects on golden-winged warbler habitat in the ROW, in particular the hypothesis that:
