**Bipole III Transmission Project**  
**Construction Environmental Protection Plan**  
**Construction Section C1**  
**Environmentally Sensitive Site Locations**

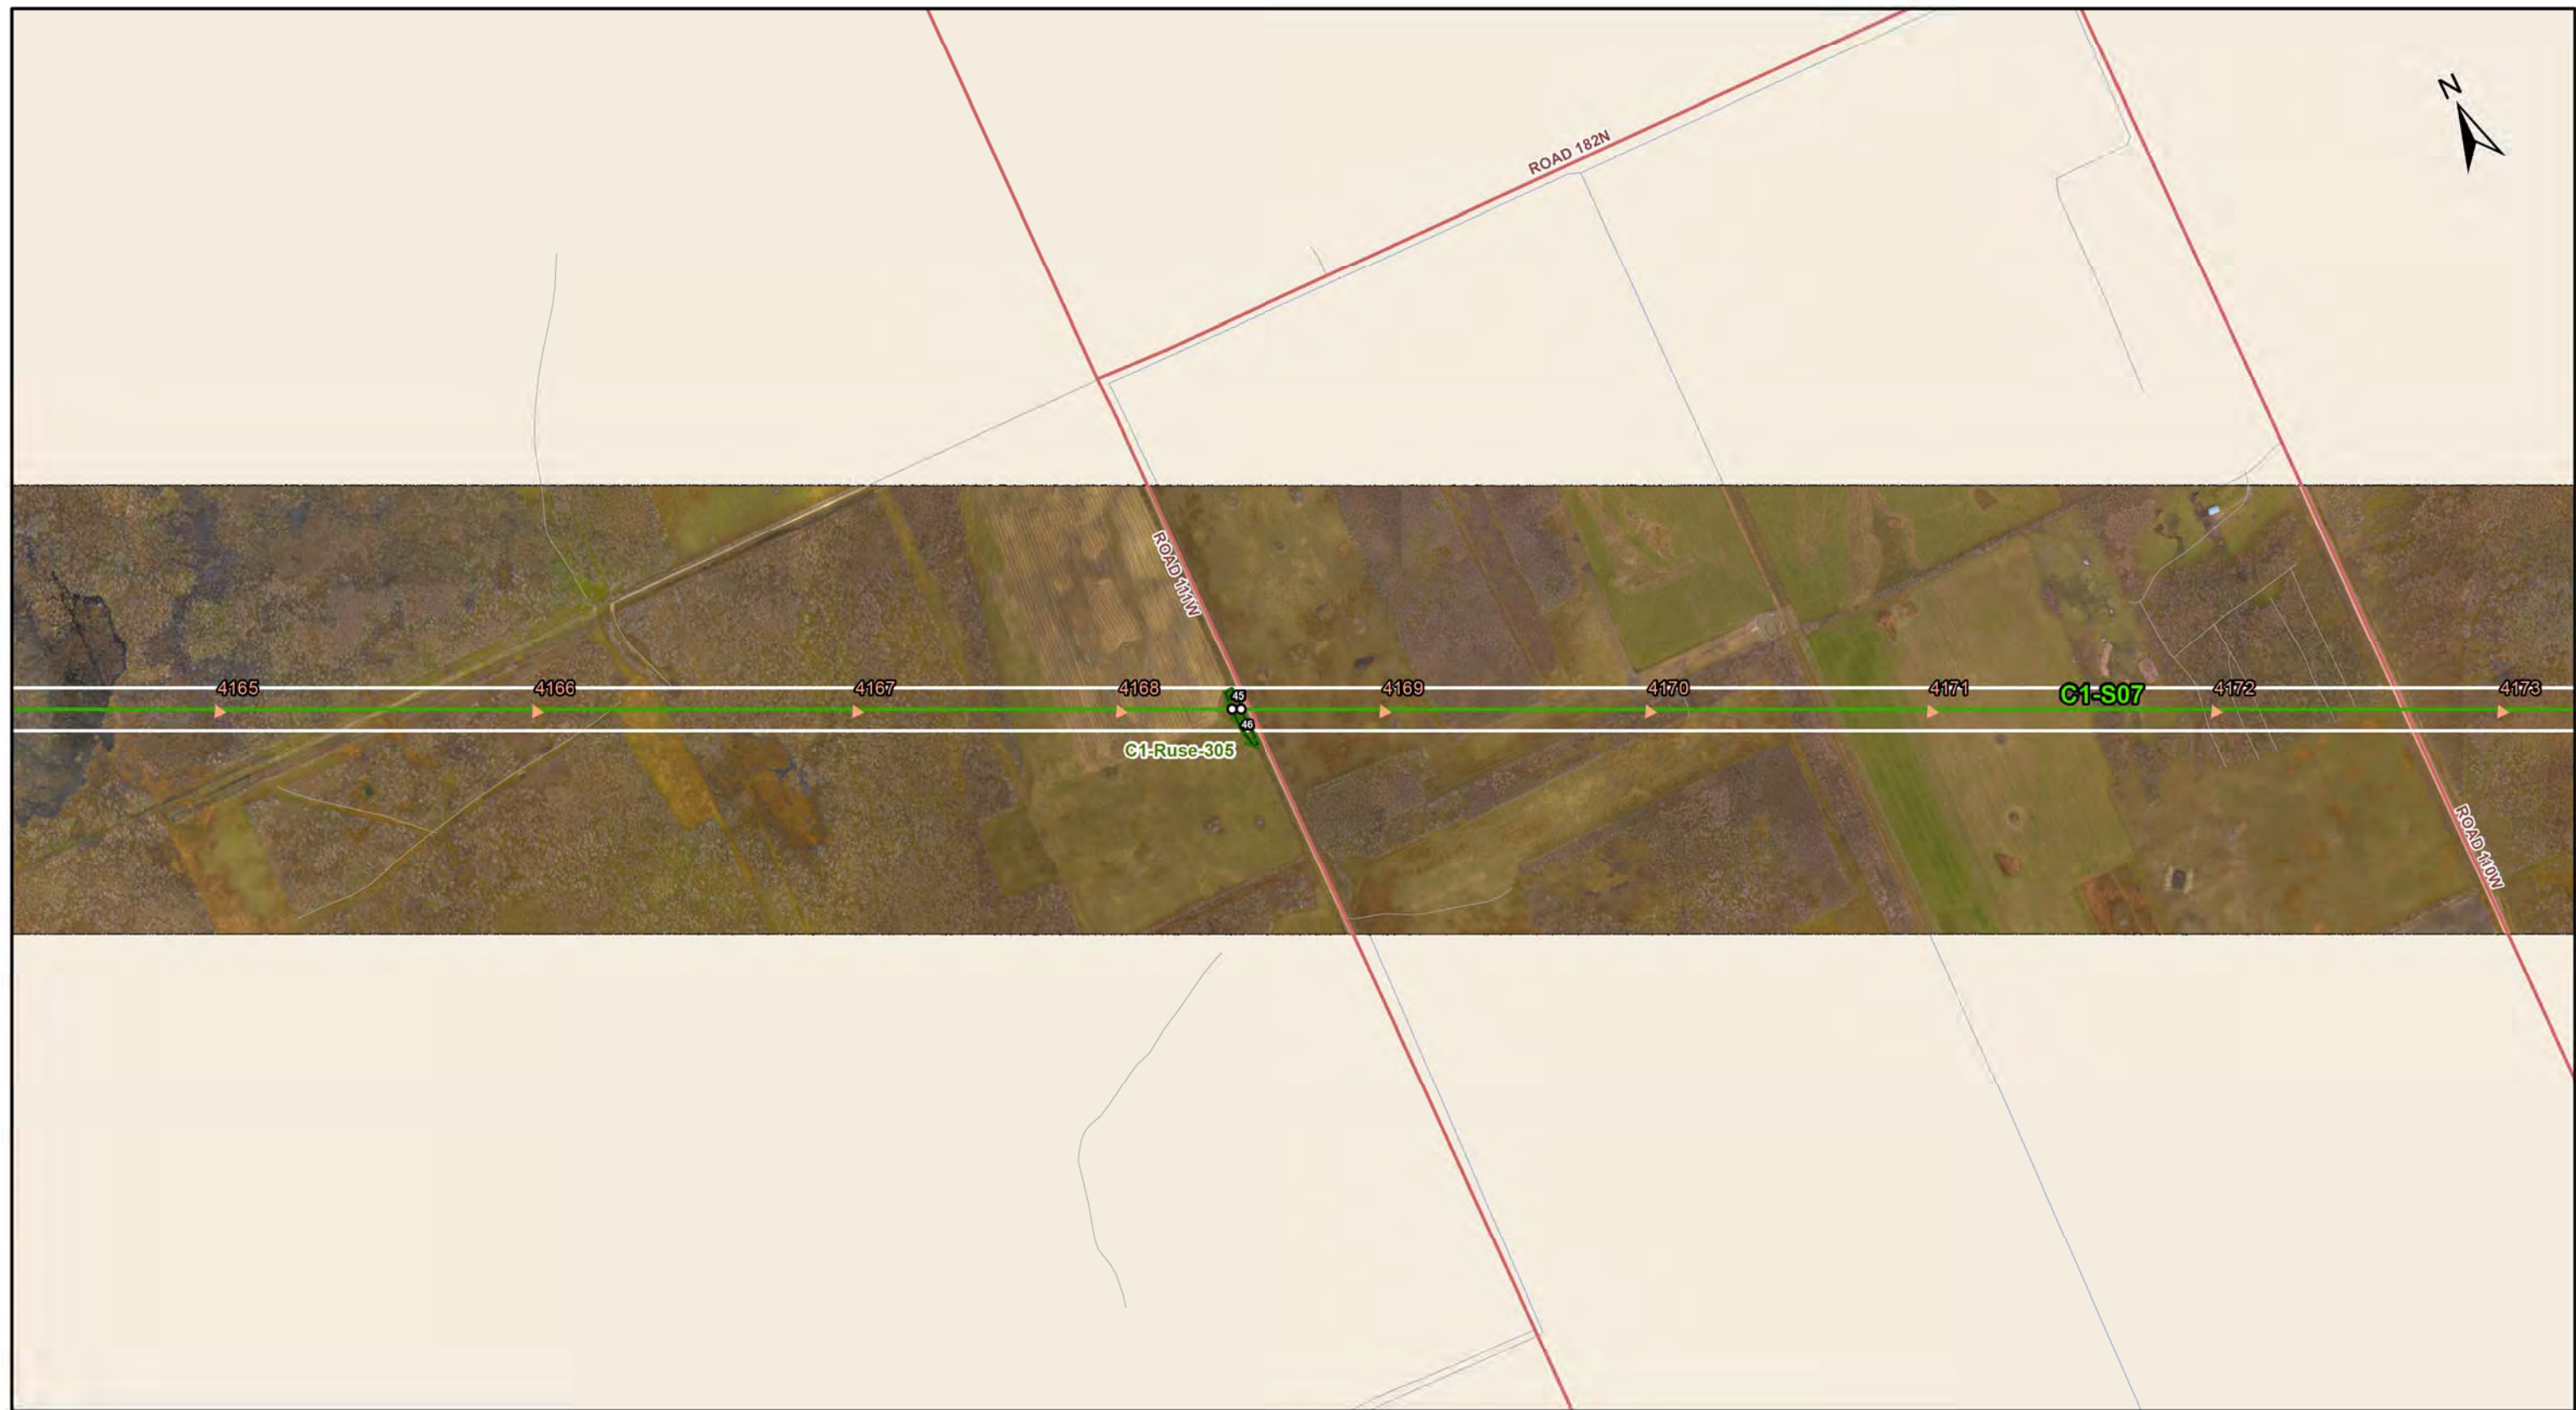
ESS Group: Forestry

| Sec-Seg ID | ESS ID | ESS Name | Location | Start | Stop | UTM Zone | Distance |
| C1-S07 | C1-RUse-305 | Shelterbelt | Site: 45 to 46 | E-424910<br>N-5722439 | E-424922<br>N-5722433 | 14N | 13m |

Removal in area of ROW intersect

- Carry out construction activities on frozen or dry ground to minimize surface damage, rutting and erosion
- Identify and flag prior to start of work
- If Burning of clearing debris is required it must be conducted during winter months only and ensure that all fires are extinguished prior to spring break-up
- Notify landowner regarding construction activities and schedule, and address concerns prior to start of work
- Use existing access trails, roads or cut lines whenever possible as access routes
- Limit all equipment to project footprint only, where possible
- No damage to Vegetation on the edge of the Right of Way
- No pushing debris into adjacent timber
